#### PROJECT SPECS

**Surface type:** SPF (recoat)

**Location:** South Florida

## An acrylic coating is a bad idea for a roof that ponds water.

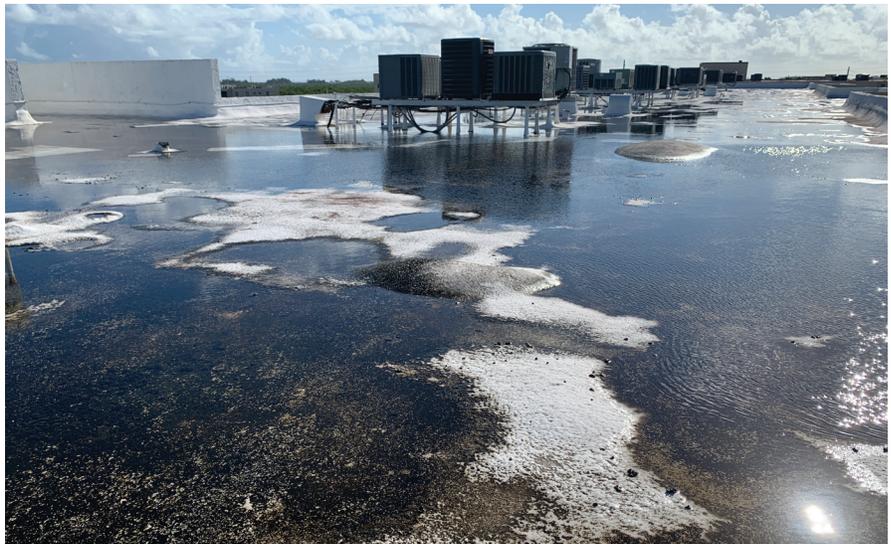
What they found was an extremely flat Spray Polyurethane Foam roof that was coated with an acrylic coating. Spray foam makes a great roof because it is both water-tight and offers incredible insulation, but the key consideration of an SPF roof is that it is not UV stable—foam roofs must be top-coated. An acrylic top coat, however, is not recommended for roofs with ponding water issues. An acrylic coating works great on roofs with positive drainage, but not on roofs that pond water. This particular SPF roof is not actually flat, but more like a bowl with very few drains for water. The acrylic coating was failing over 60% of the roof. If something wasn't done in the next year, this roof could be a total loss.

Ponding water with acrylic debris

As a solution, the contractor proposed the Envir-O-Sil system to repair and restore the roof.

First, an adhesion test patch was performed to ensure the system would adhere to the existing membrane. Next, the roof was pressure-washed to remove any dirt, dust, debris, and loose coatings. Then, Terminator 622—a thick waterproofing sealant that adheres especially well to silicone—was used for select problem areas of the roof in need of repair. All seams, fasteners, penetrations, and transitions were then coated with Silicone Brush-Grade 422. Once the problem areas and flashing details were addressed, two coats of High-Solids Silicone 412 were then applied to the roof. This low VOC product forms a weather-resistant, rubber-like seal and provides the roof with excellent UV protection and weatherability.

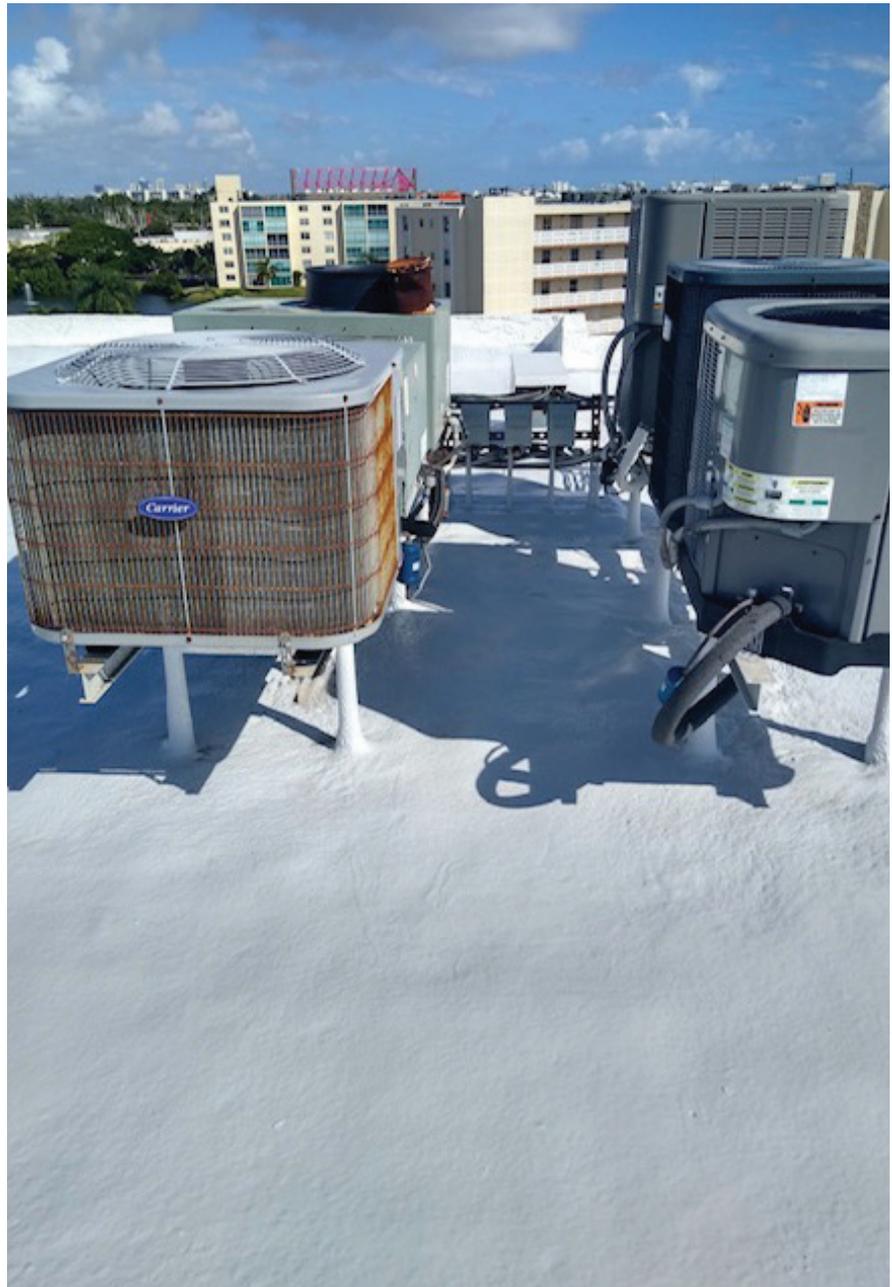
Completed project

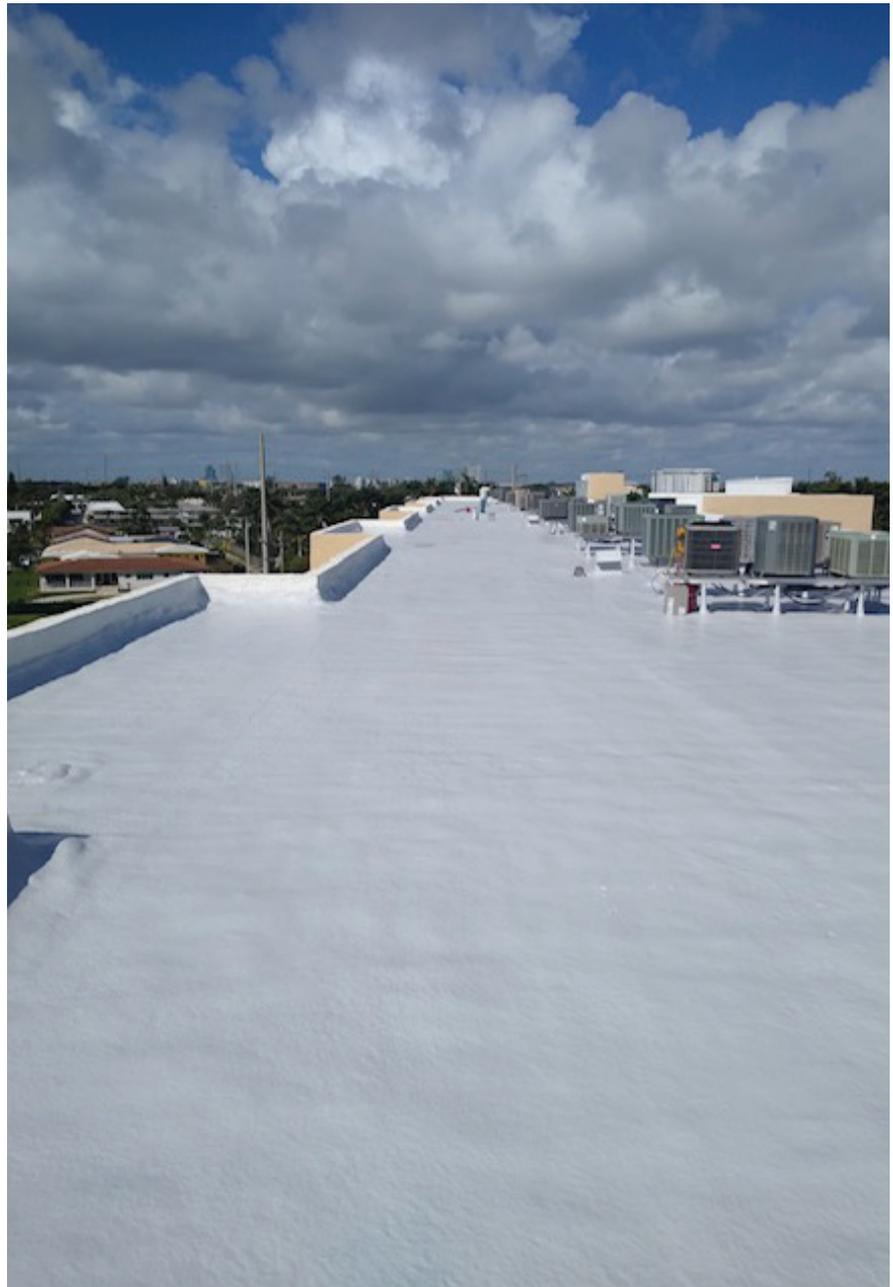
Completed project
