PROJECT SPECS**Surface type:** Masonry**Size:** 4,300 sq. ft.**Age:** 20+ Years**Location:** Morrow, GA**Industry:** Hospitality**Solution:** Wall-Coat**PRODUCTS**

The Wall-Coat System seals and renews leaking masonry wall.

RESEARCH

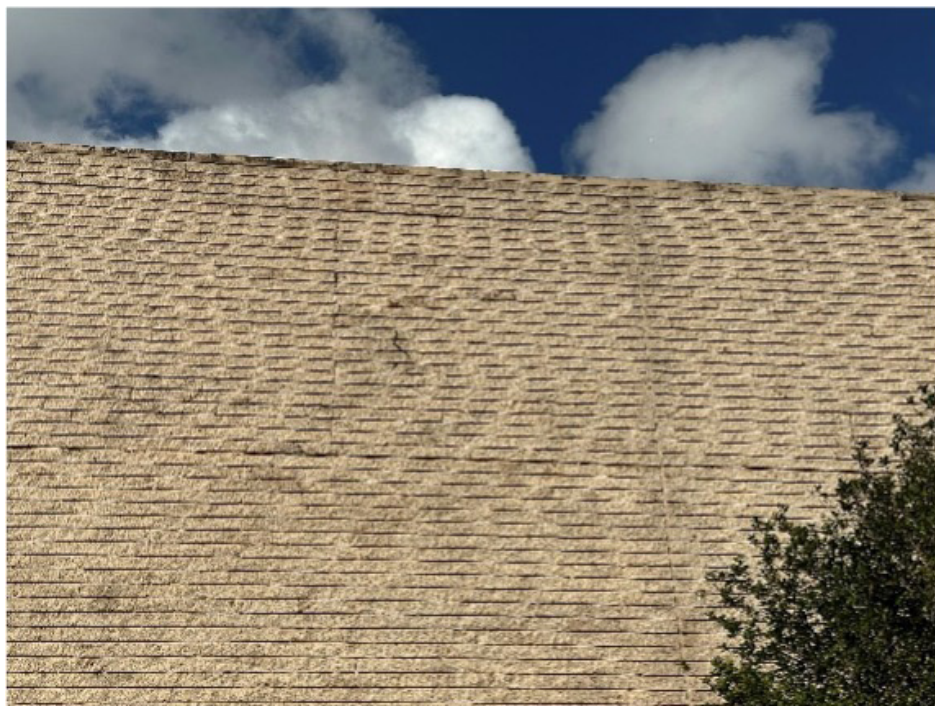
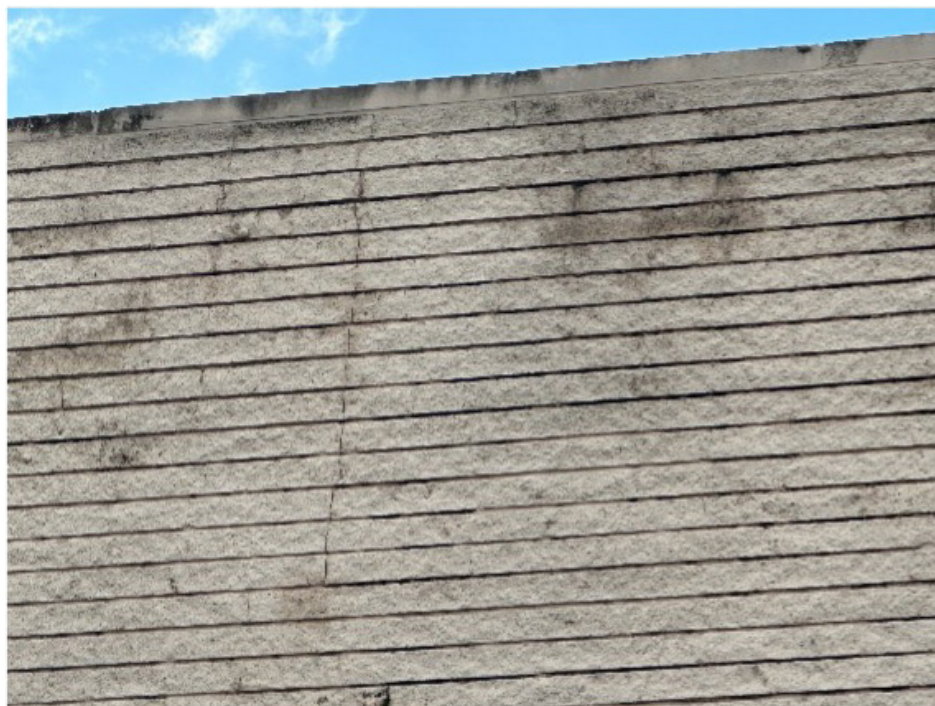
At an event space in Morrow, Georgia, the facility manager reported multiple leaks around the perimeter of the building. After resealing the surface-mounted counter flashing and re-flashing several wall support penetrations, the building continued to have leaks. Upon further investigation and water testing, moisture was found behind the single-ply membrane base flashing. It was determined that water was intruding through the seven-foot parapet wall.

LEAKING WALL BEFORE RESTORATION

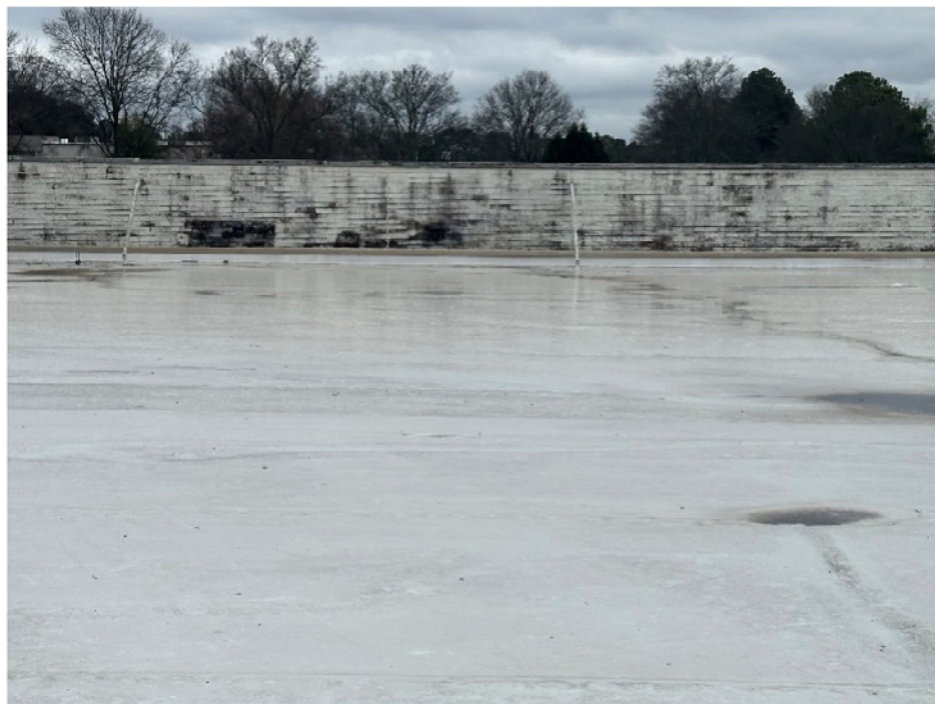
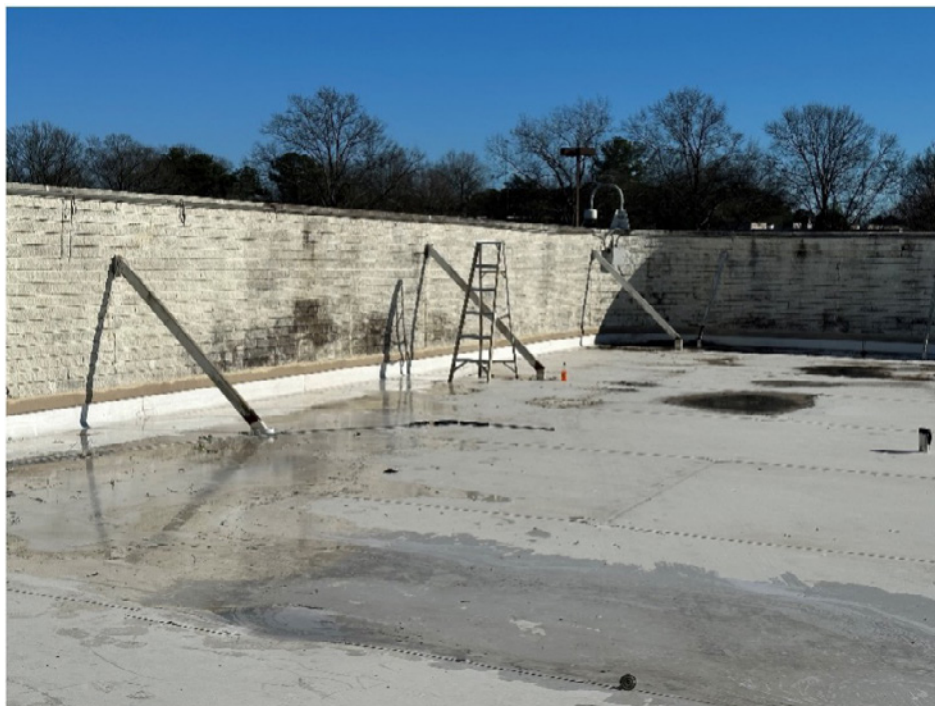
LEAKING WALL BEFORE RESTORATION

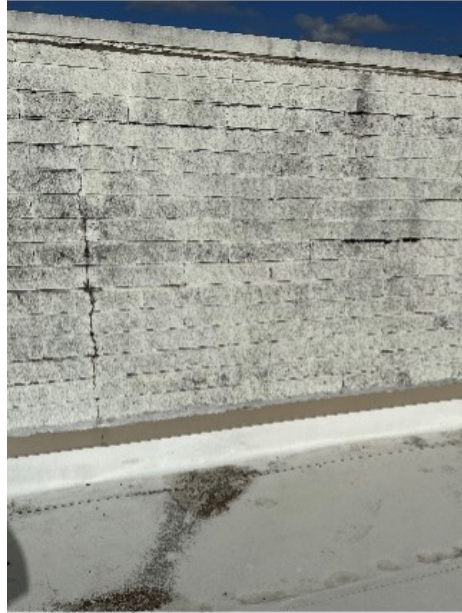
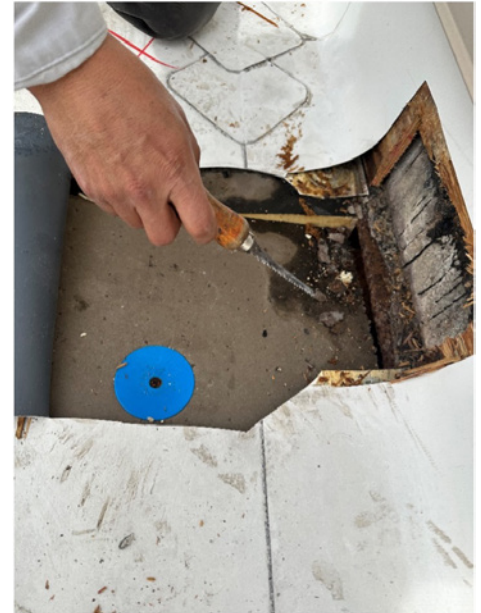
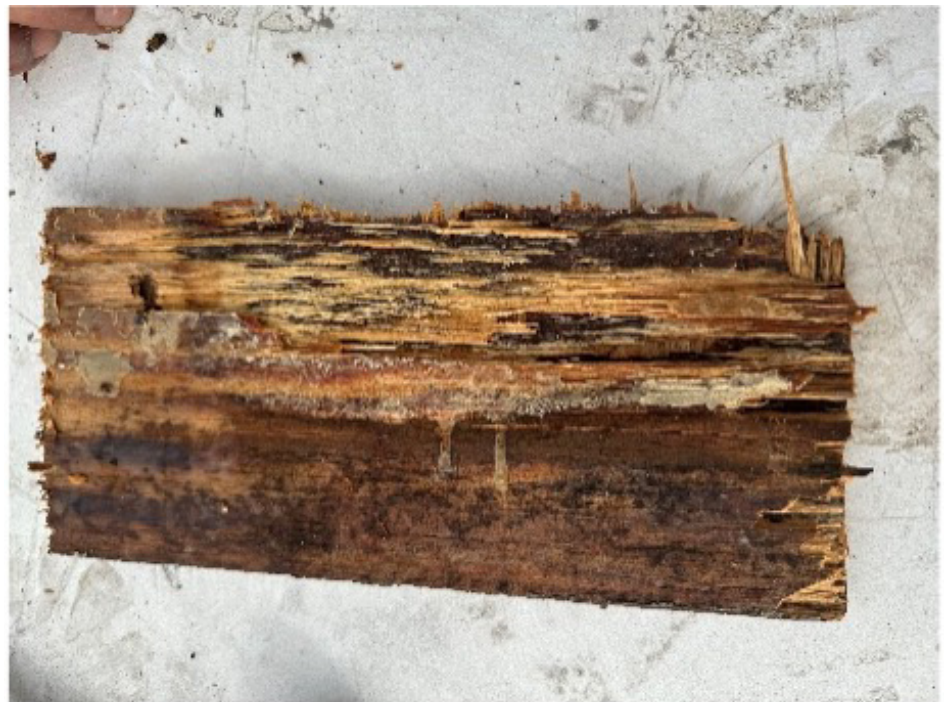
LEAKING WALL BEFORE RESTORATION

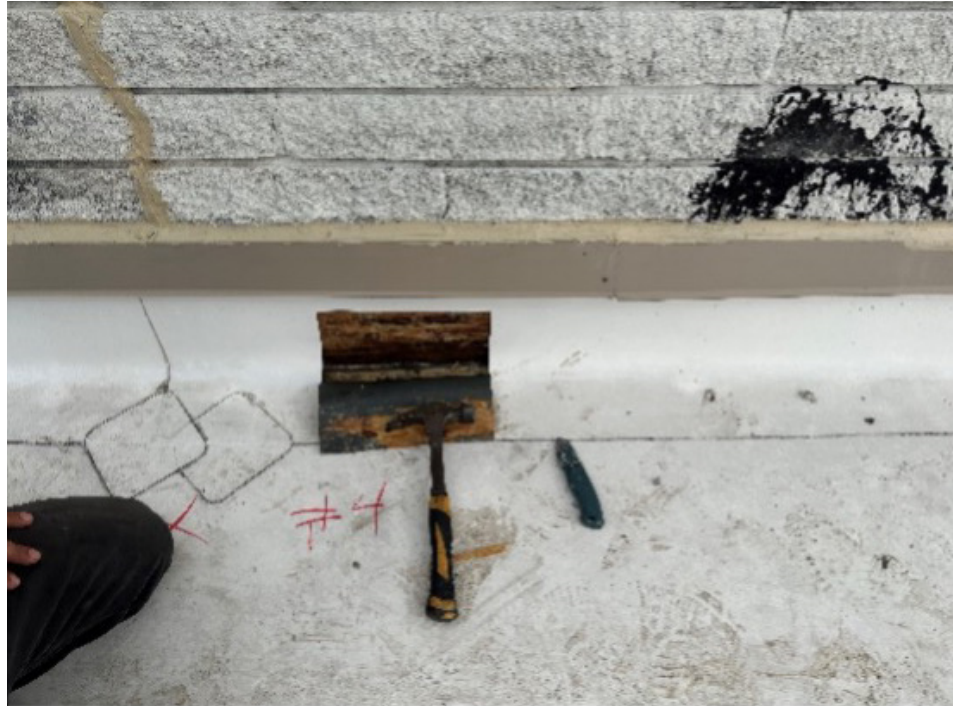
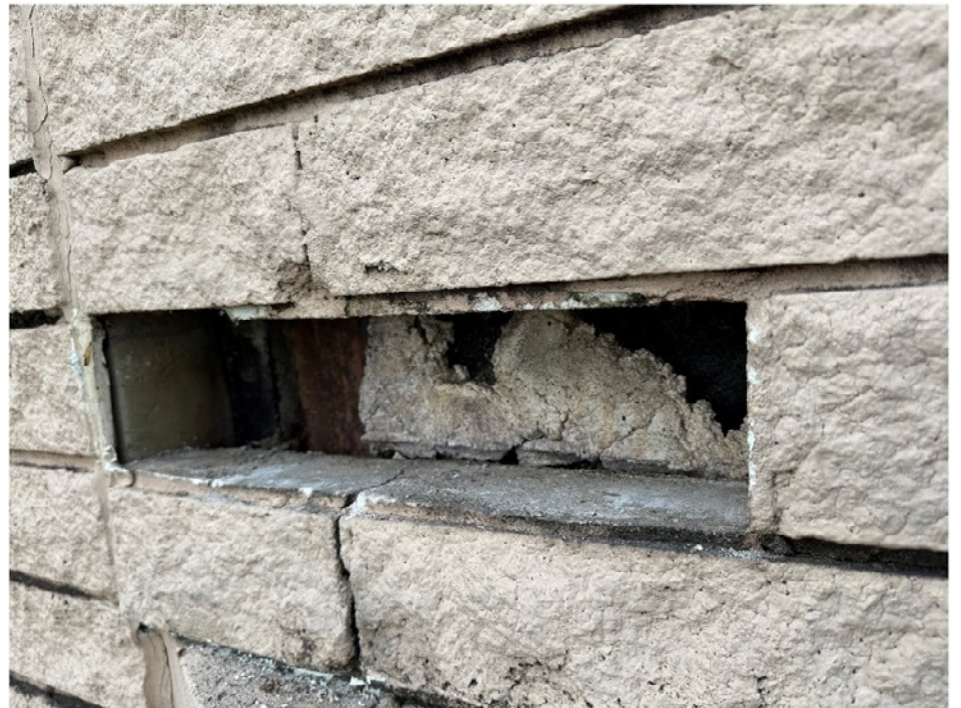
LEAKING WALL BEFORE RESTORATION

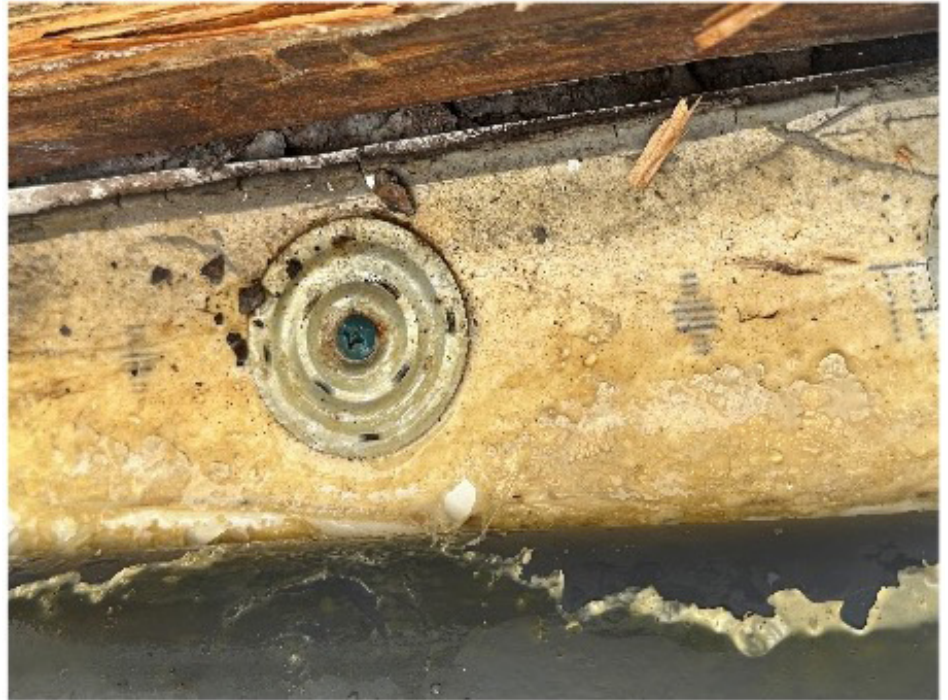
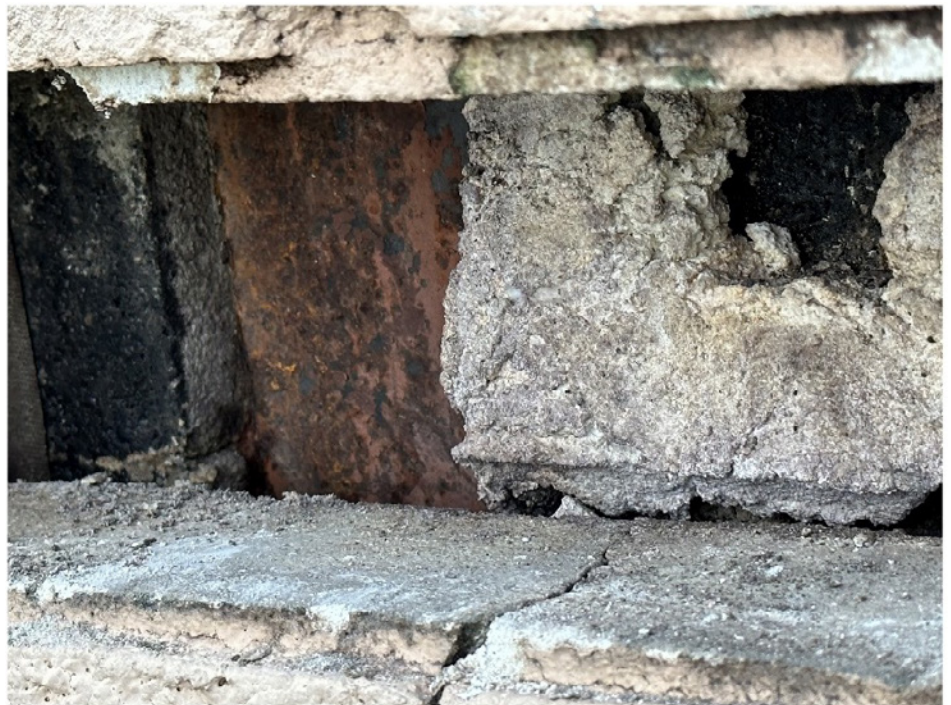
LEAKING WALL BEFORE RESTORATION
