**PROJECT SPECS****Surface type:** Modified Bitumen**Size:** 3000 sq. ft.**Age:** 12+ years**Location:** N/A**Industry:** Food Service**Solution:** Ure-A-Sil**PRODUCTS**

The Ure-A-Sil system performs even in the harshest conditions.

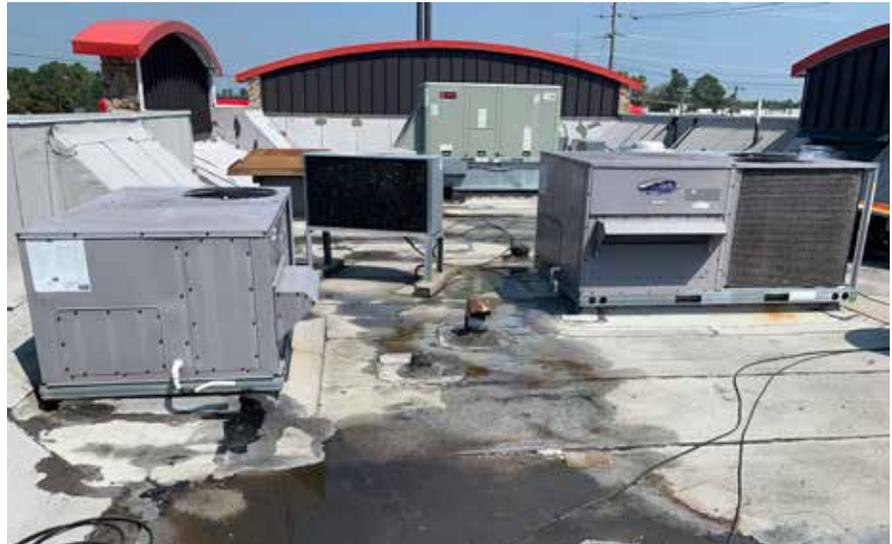
Leaks

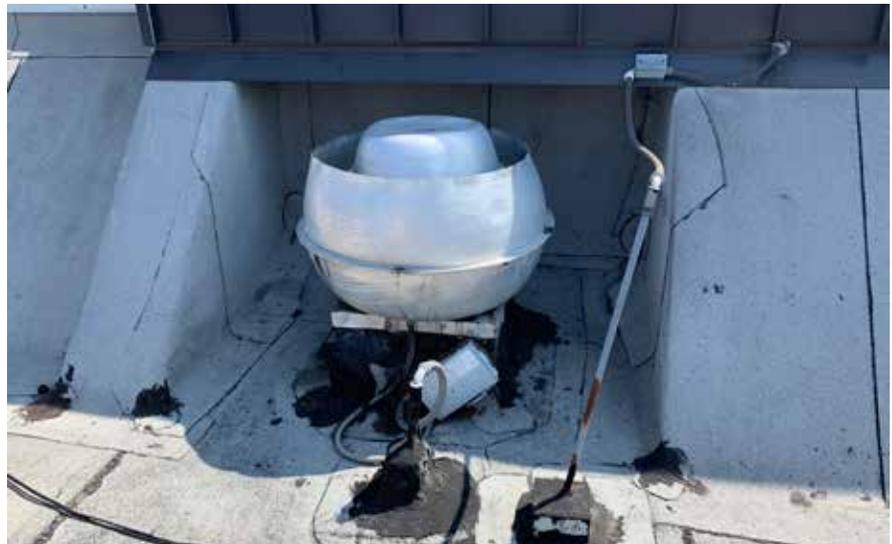
Untreated penetration

Next, Urethane Brush-Grade Urethane 522, a thick waterproofing mastic, was used to seal all seams, fasteners, penetrations, and transitions. Once the problem areas and flashing details were addressed, a base coat of Aromatic Urethane 520 was applied. Finally, the American WeatherStar Approved Contractor applied a top coat of Silicone 410 to complete the project.

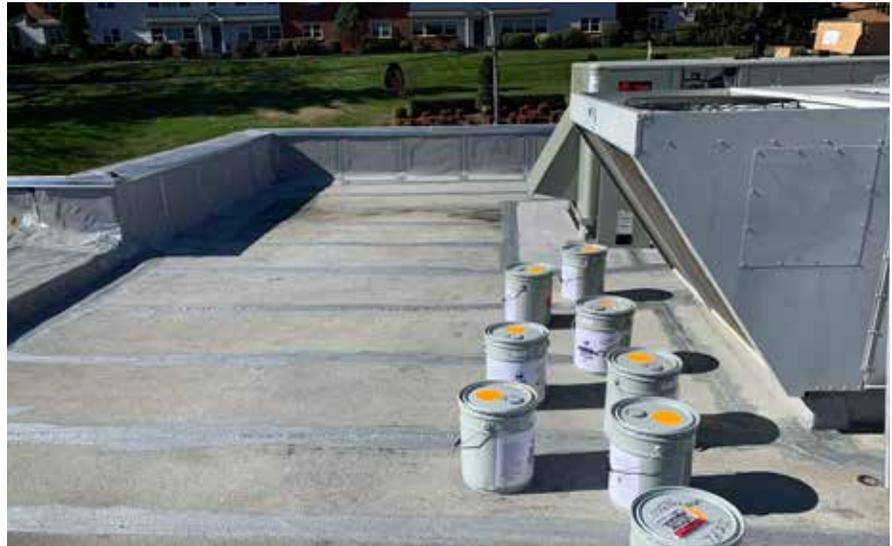
Seam waterproofing

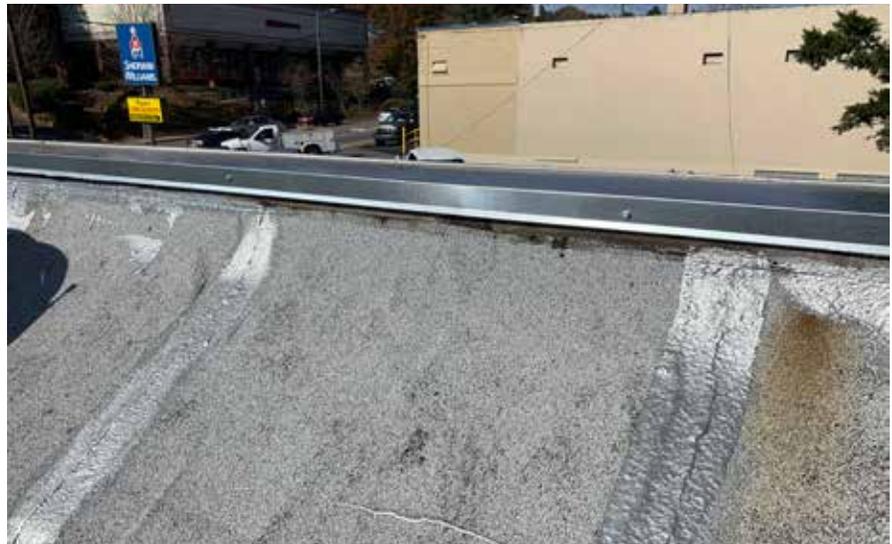
Waterproofing detail

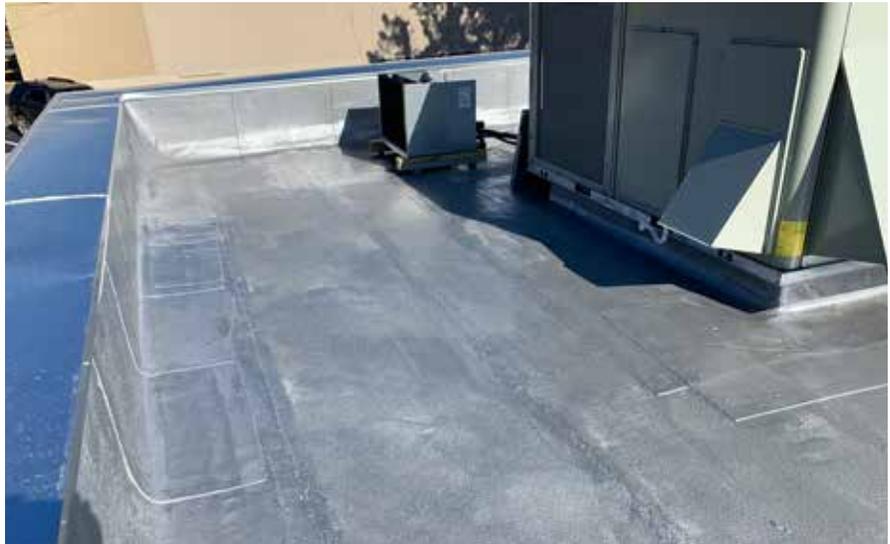
Urethane 520 base coat

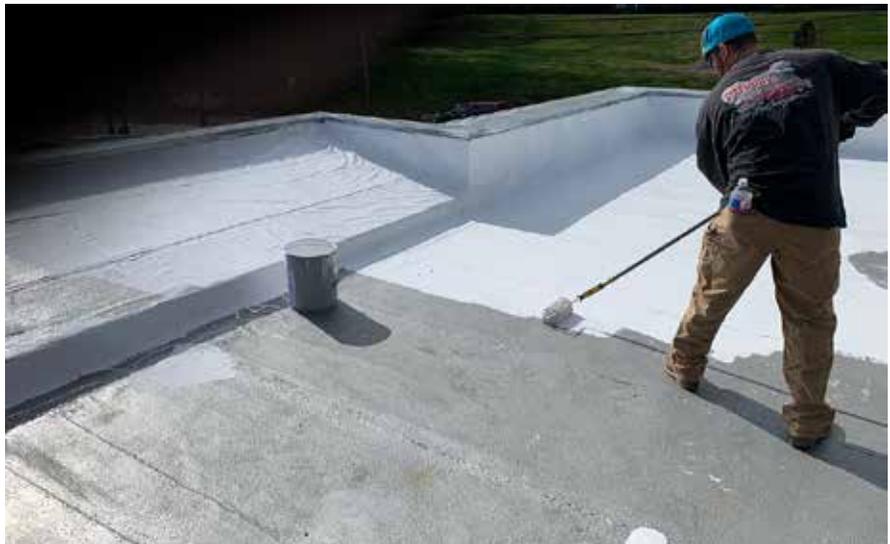
Silicone 410 top coat
