#### PROJECT SPECS

**Location:** Satsuma, AL

**Solution:** Envir-O-Sil

## Some roofs receive multiple coatings systems during their lifespan.

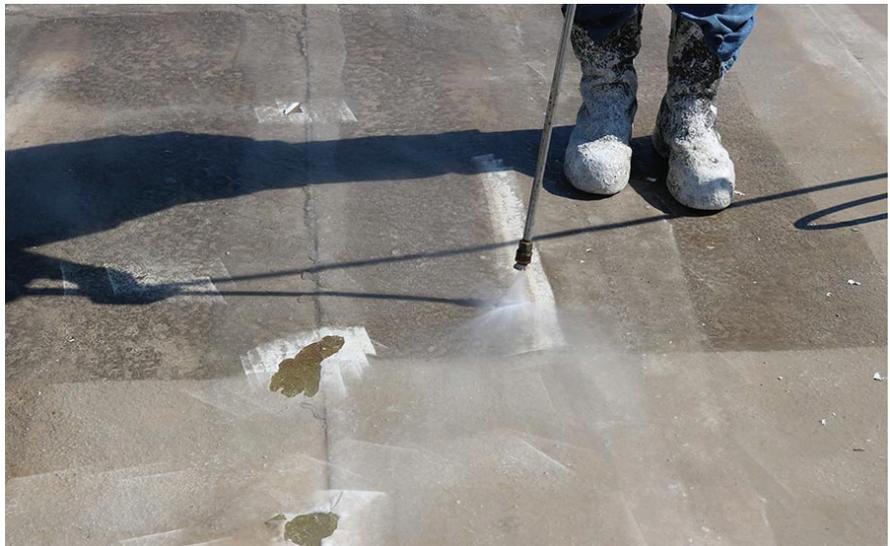
Surface Prep

First, an adhesion test patch was performed to ensure the system would adhere to the existing membrane. Next, the roof was pressure washed to remove any dirt, dust, debris, and loose coatings. Next, Terminator 622—a thick waterproofing sealant that adheres especially well to silicone—was used for select problem areas of the roof in need of repair. All seams, fasteners, penetrations, and transitions were then coated with Silicone Brush-Grade 422. Once the problem areas and flashing details were addressed, two coats of High-Solids Silicone 412 were then applied to the roof. This low VOC product forms a weather-resistant, rubber-like seal and provides the roof with excellent UV protection and weatherability.

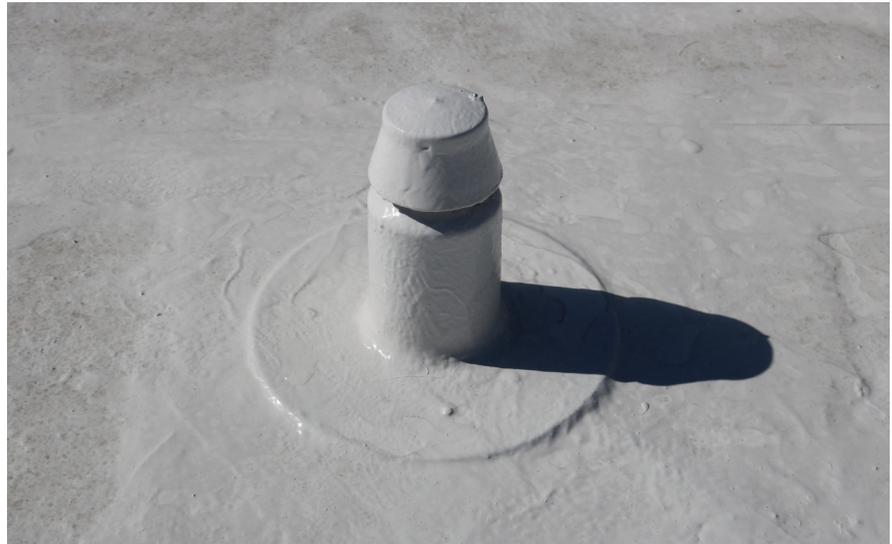
Penetration

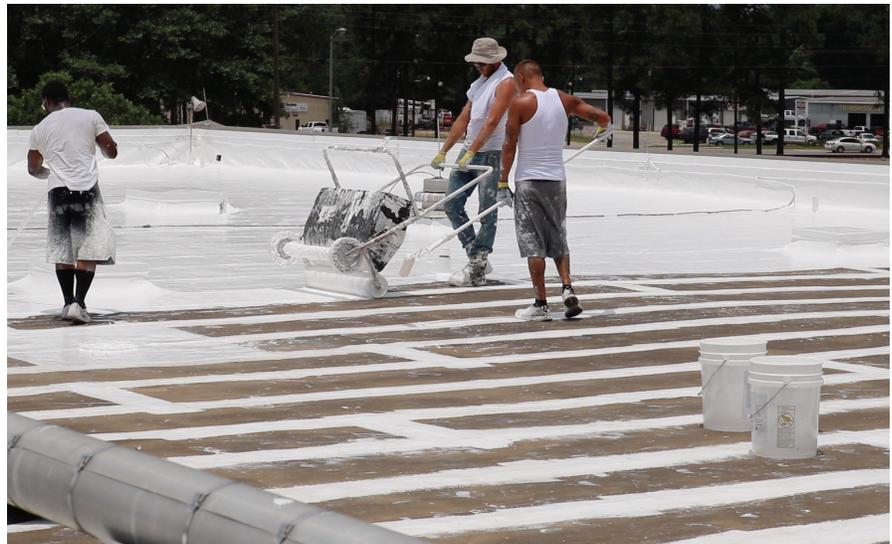
Base Coat

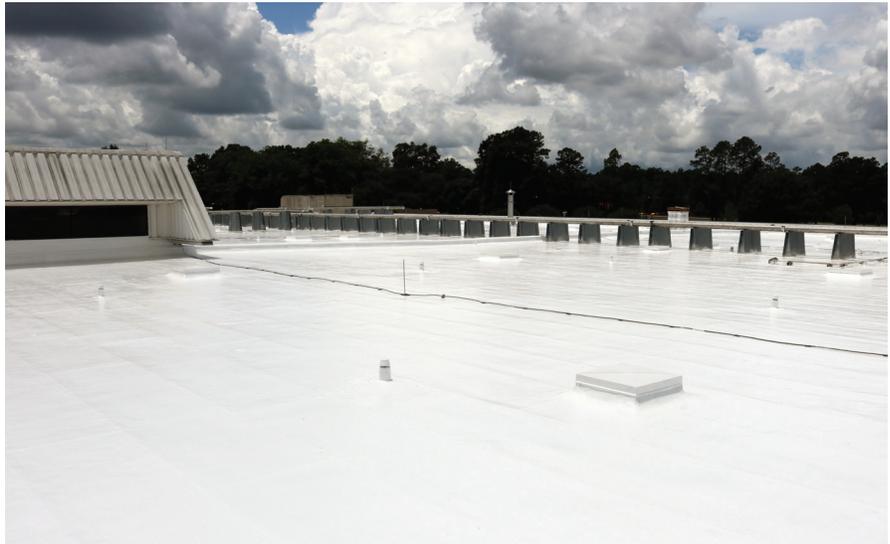
Top Coat

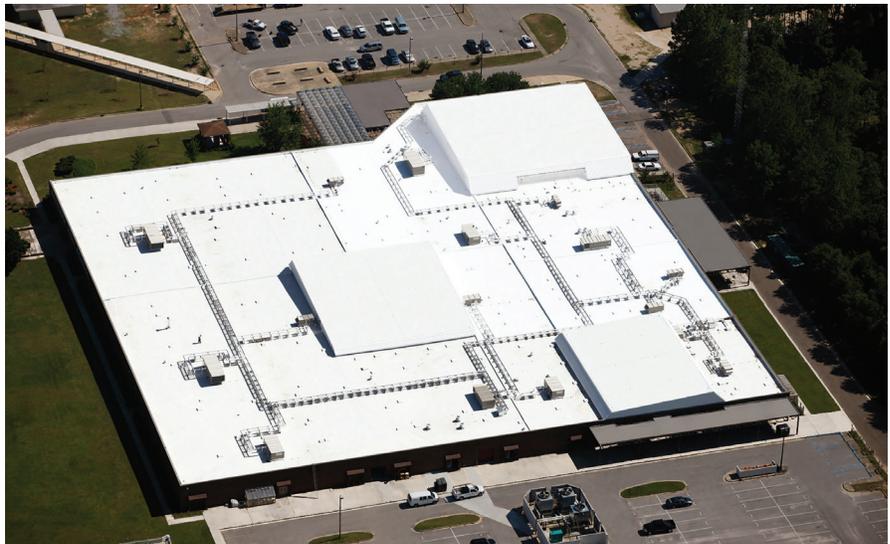
Complete

While the main objective of this project was to stop leaks, proper treatment of the seams and other flashing details will ensure the long-term success and performance of this newly-installed system.

Once completed, the roof received an additional 10 years of warranty protecting it from any future leaking problems. For the school system, the Envir-O-Sil System was a much more cost-effective alternative to a full roof replacement.
