FLAT ROOF: THREE COURSE FABRIC REINFORCED

OUTSIDE CORNER RESTORATION DETAIL

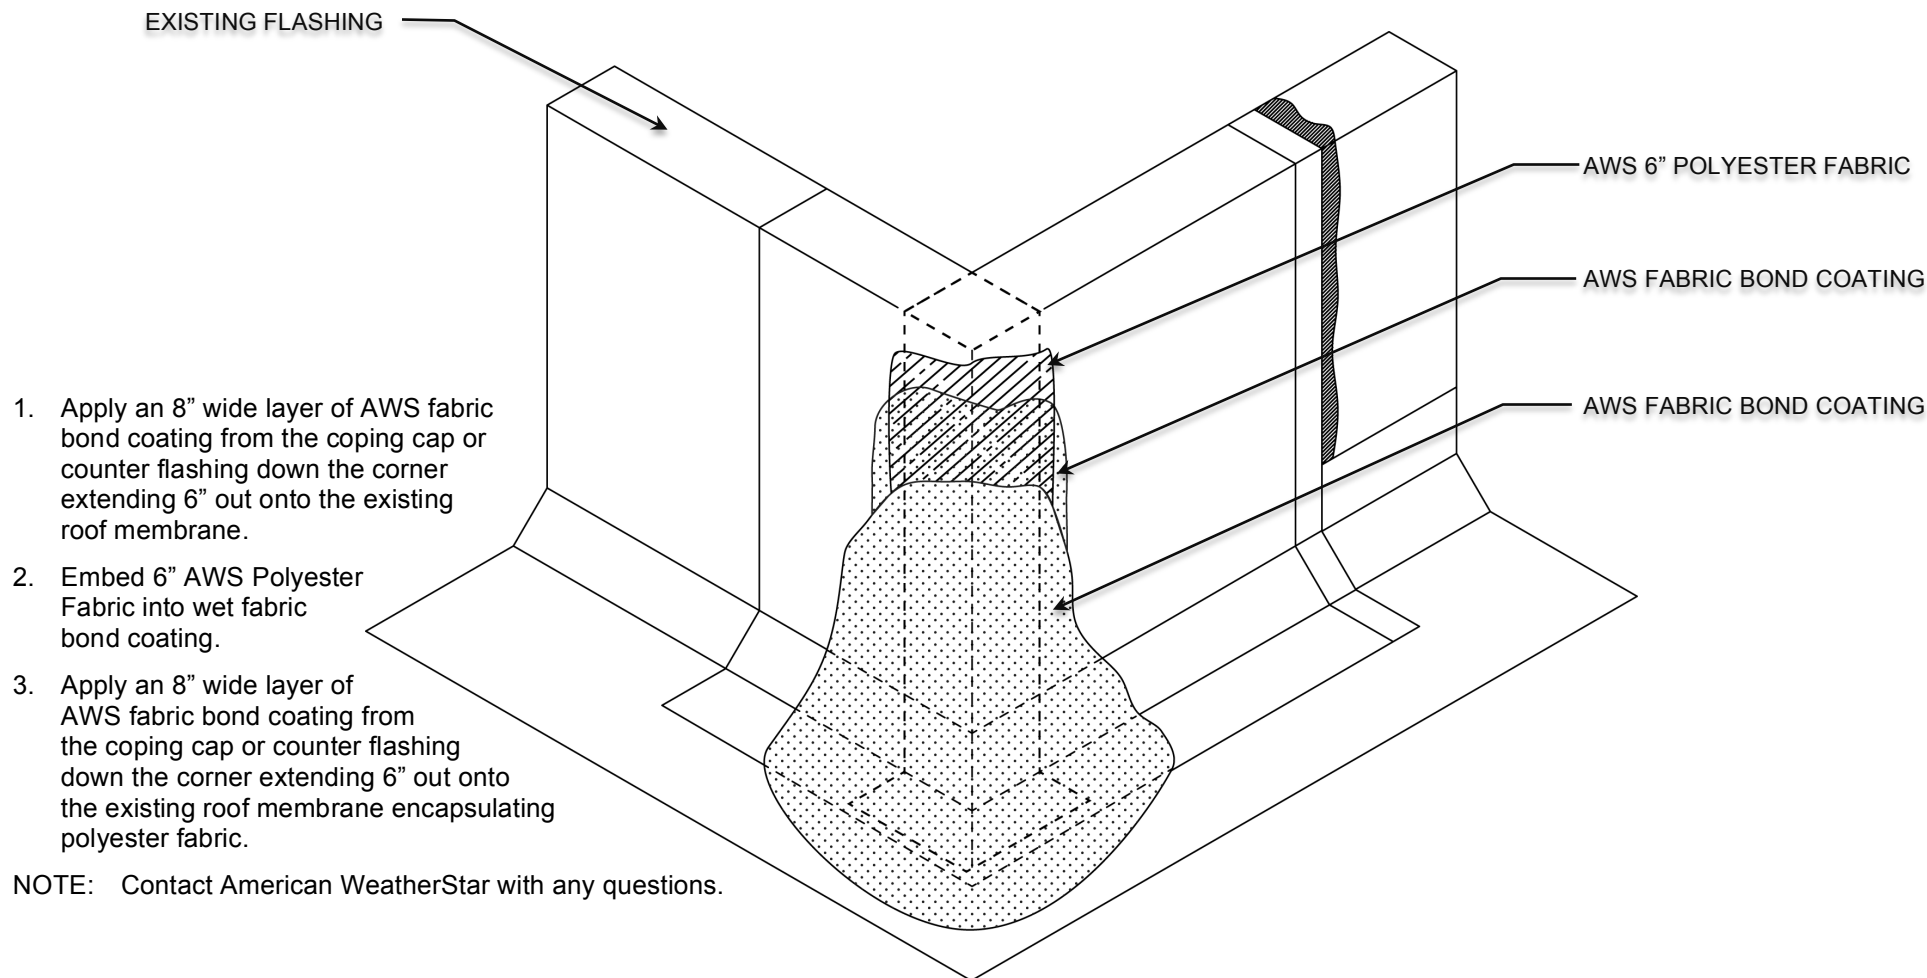
See specific application guideline for suitable AWS fabric bond coating.
