**PROJECT SPECS****Surface type:** Metal**Size:** 21,000 sq. ft.**Age:** Unknown**Location:** Louisville, KY**Industry:** Shipping & Freight**Solution:** Foam-Gard SPF**PRODUCTS**

- Spray polyurethane foam
- High-Solids Silicone 412

## The Foam-Gard system brought this “Frankenstein” roof back to life.

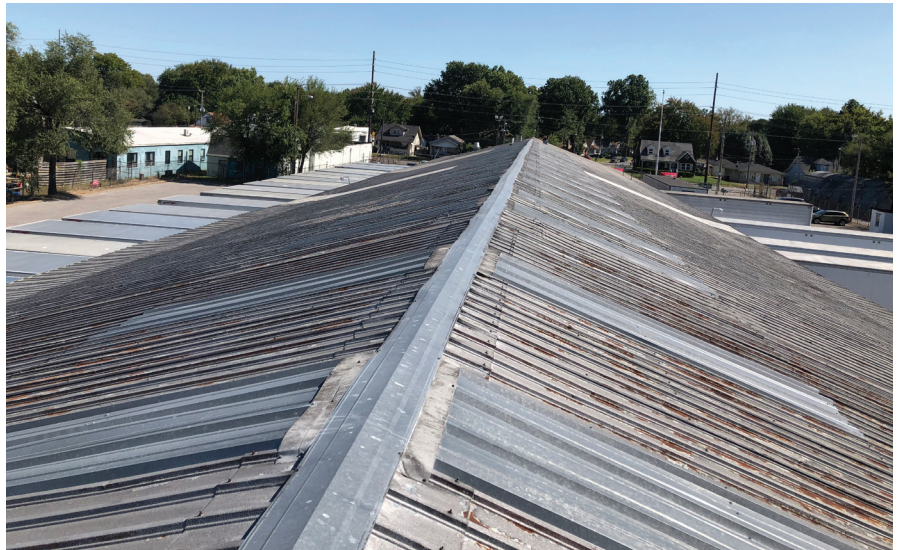
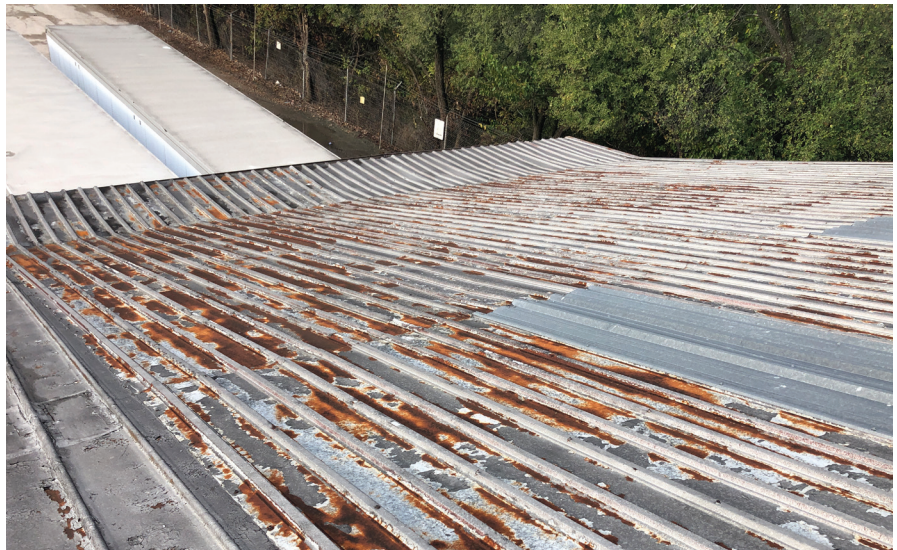
This metal roof in Louisville, Kentucky required restoration primarily for addressing small leaks, deteriorated materials, and damaged gutters and z purlins. The building owner had previously made multiple attempts to fix the issues with no success—the roof consisted of 3-4 different metal profiles all with different levels of corrugation, making it difficult to properly connect the existing roof to other panels, areas, and expansion joints. Additionally, the roof already had multiple types of repair coatings previously applied to it including asphalt, urethane, silicone, acrylic—all of which were rushed and not given proper prep work to ensure correct installation and proper adhesion. It was truly a Frankenstein’s monster of a roof!

Base roof

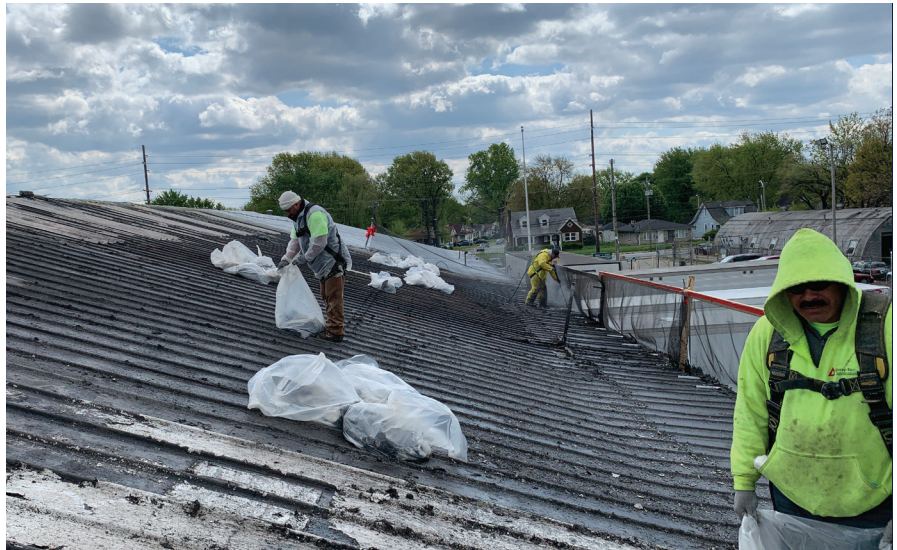
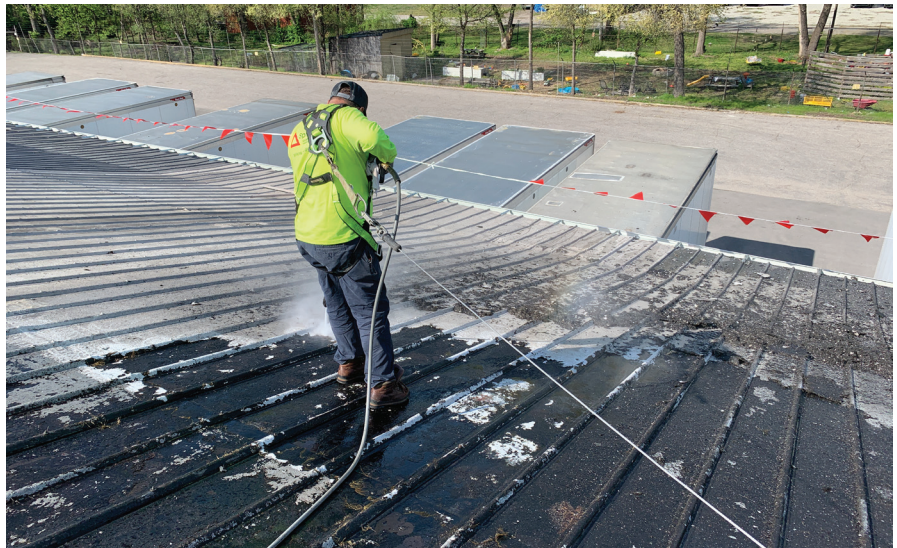
Prep phase

The installing contractor began by giving the roof an in-depth cleaning. Any coating job should begin with roof prep, but because the roof had previously been neglected in terms of prep work, the contractor made sure to properly pressure-wash and grind away old mastics. Though it was a slow process, doing so ensured proper adhesion of the 3 lb. polyurethane foam.

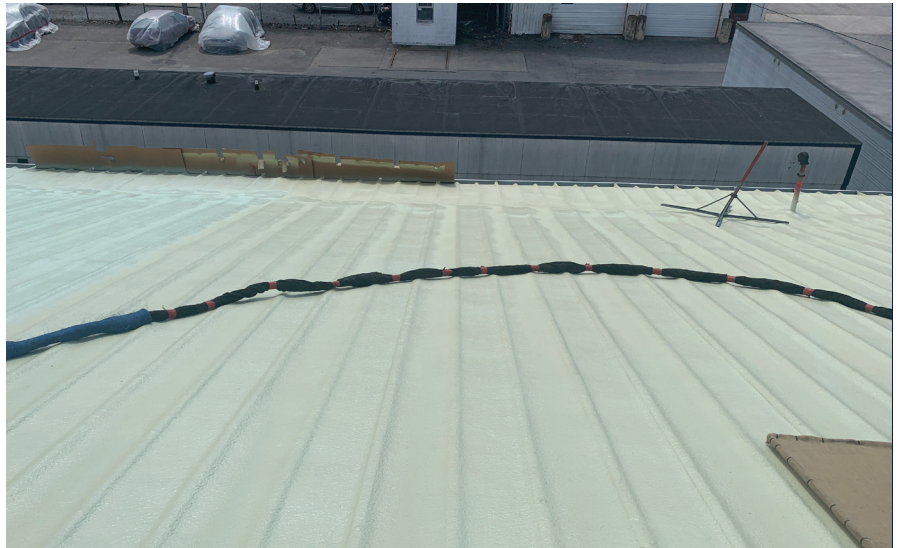
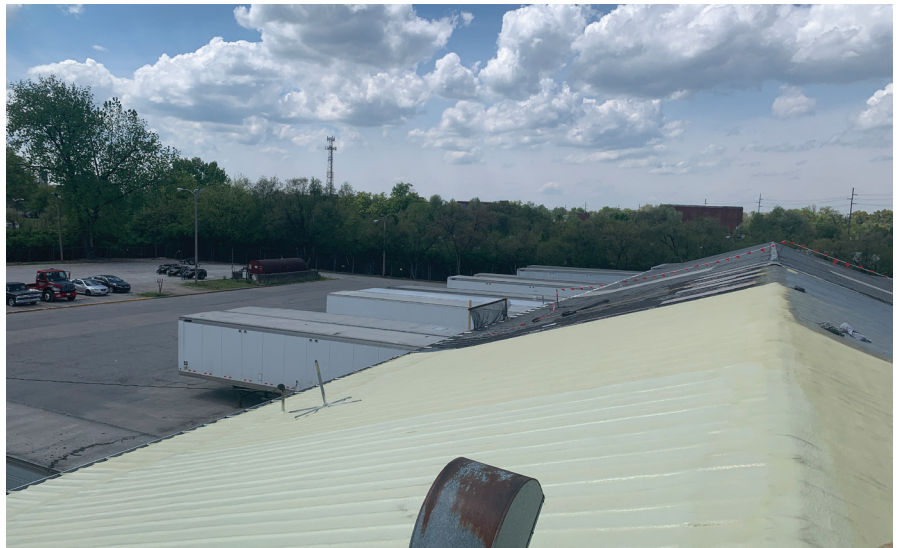
Spray foam

After installing a layer of high-density spray polyurethane foam, two coats of High-Solids Silicone 412 were applied to the roof. The base coat and top coat helped create a seamless foam system that ultimately tied all of the previously-installed differing metal panels together.

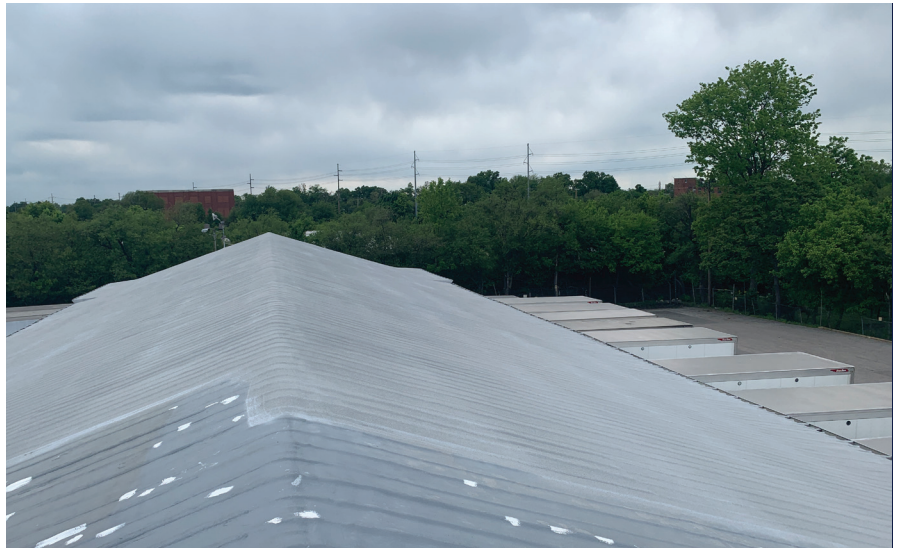
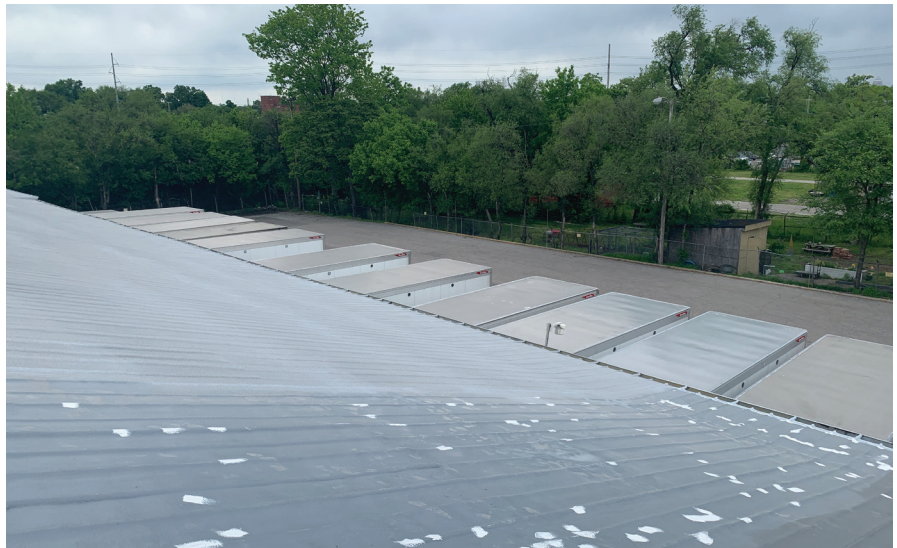
Base coat

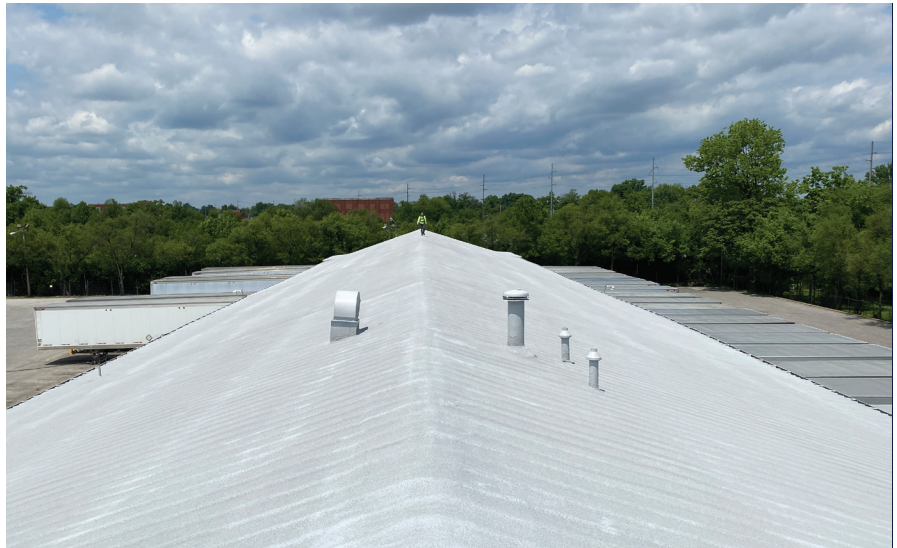
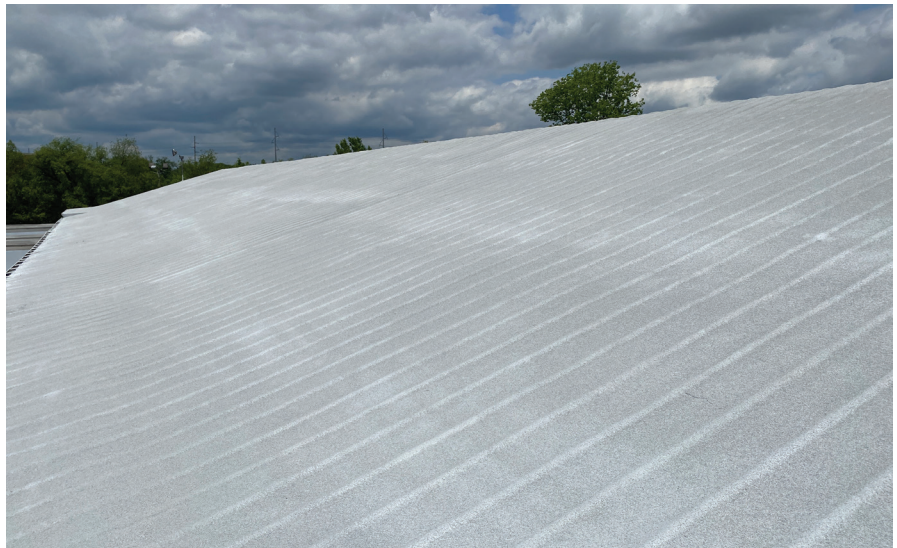
Top coat

After receiving the Foam-Gard system, the roof now has an attractive, watertight finish. The two coats of High-Solids Silicone 412 will keep the building occupants dry and insulated for many years to come.
