**PROJECT SPECS****Surface type:** Metal**Size:** 10,890 sq. ft.**Age:** 15+ years**Location:** East Stroudsburg, PA**Industry:** Government**Solution:** Met-A-Gard+**PRODUCTS**

This metal roof had serious corrosion that needed to be addressed.

An aged metal roof in East Stroudsburg, PA with two different styles of panel was in need of restoration. The roof has R-panel in some areas and Standing Seam in others. The R-panel roof specifically had a high concentration of rust and degradation that needed to be addressed prior to coating.

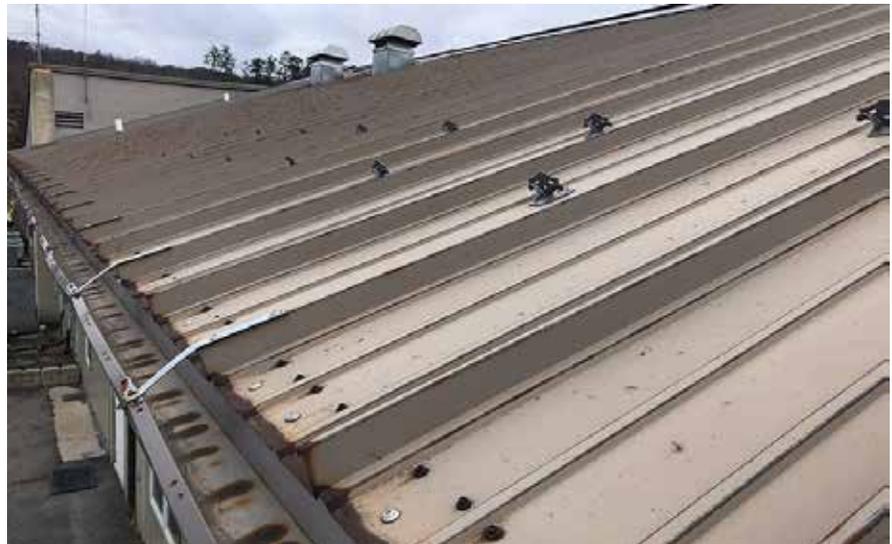
Before

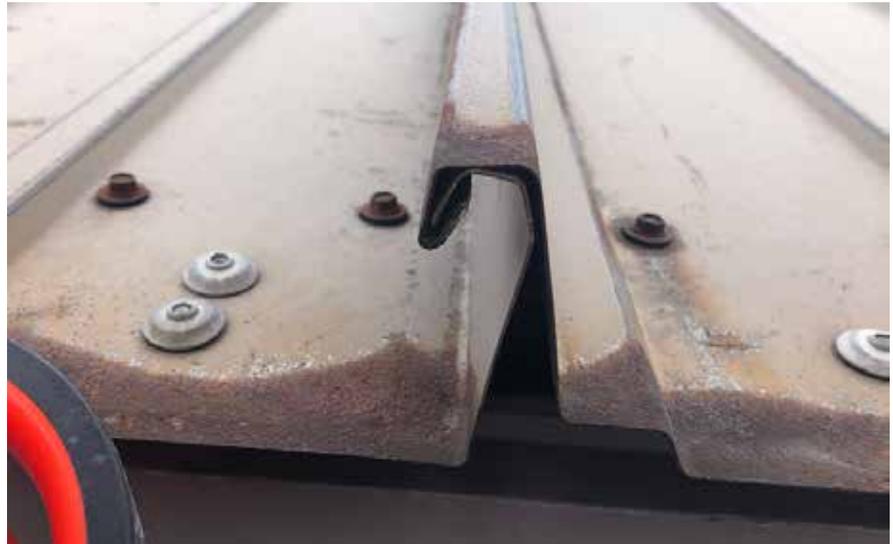
Rusted R-Panels

The installing contractor created a scope of work to ensure proper long-term performance of the Met-A-Gard+ system. First, the entire roof was pressure-washed at 3500 psi.

After preparing the substrate, Red Oxide Rust Prime 912 was applied to the roof. This primer is designed for metal roofs with significant rust damage.

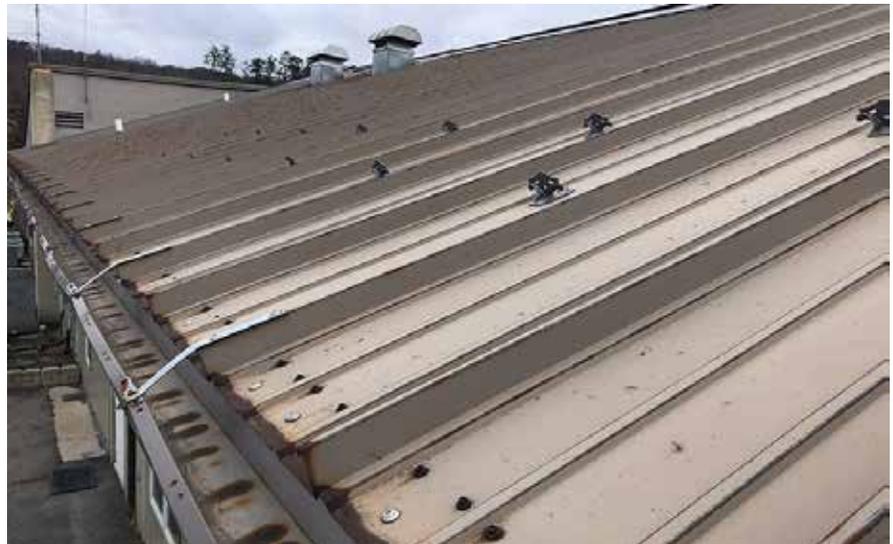
Rusted R-Panel Roof

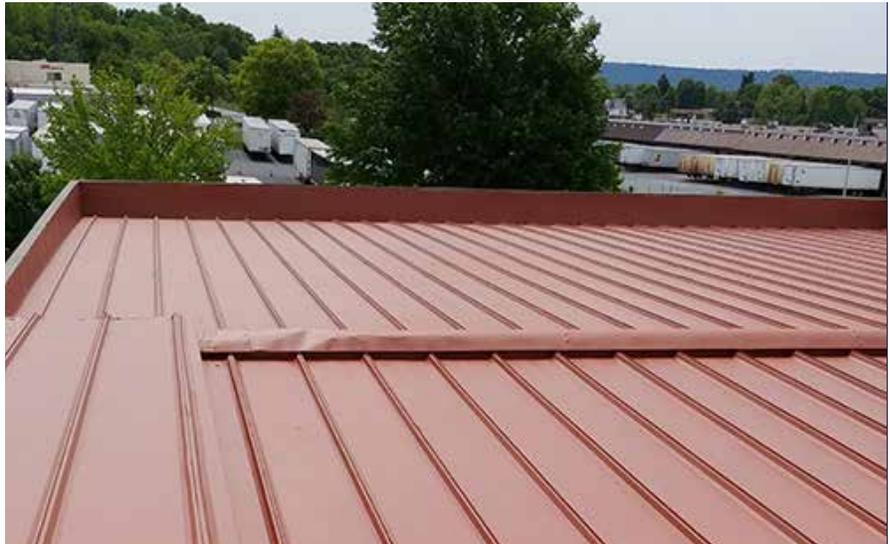
Primer

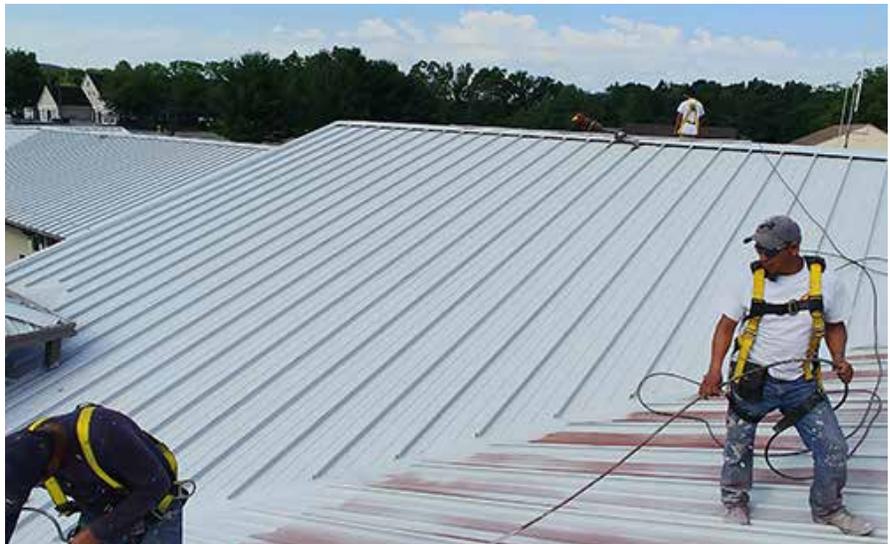
Base Coat

Then, the contractor applied a base layer of High-Tensile Acrylic 211. Typically, the Met-A-Gard+ system uses an ivory-tinted base coat so it can be differentiated from the white top coat. In this project, however, the customer chose a tan top coat, so the base coat was white.

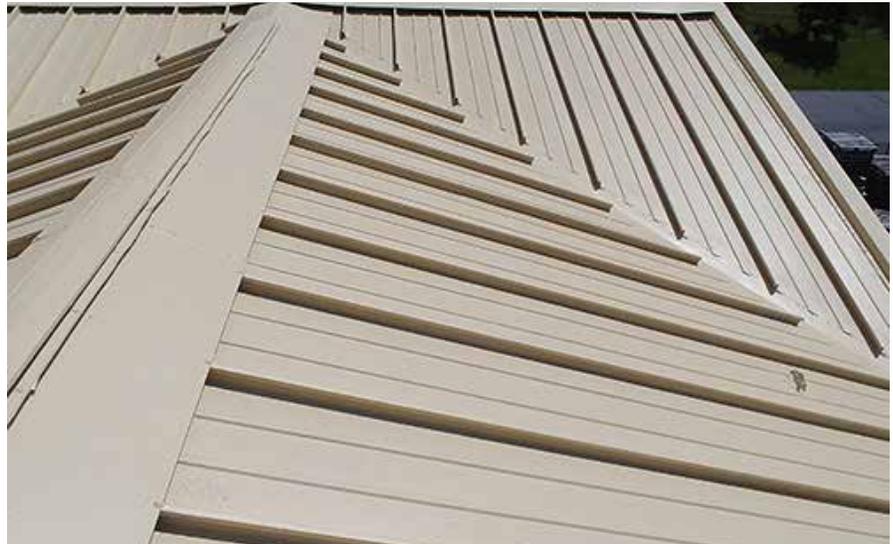
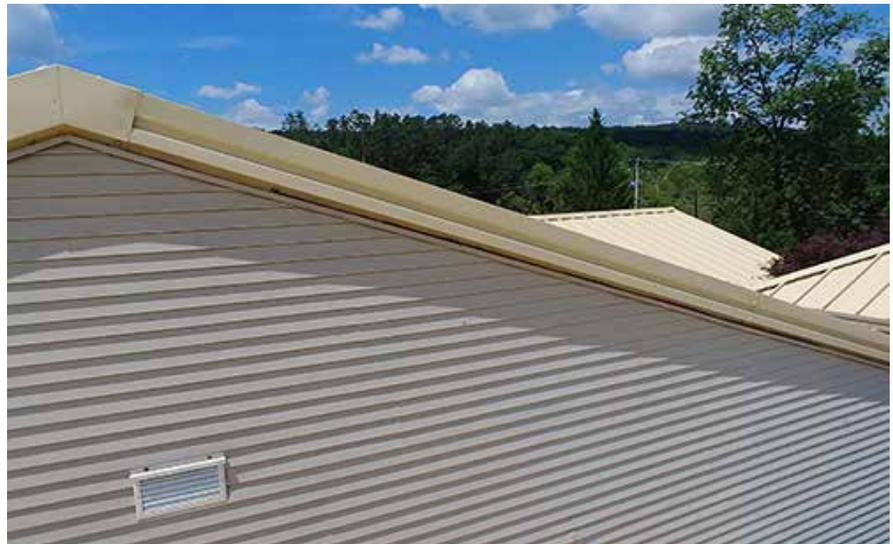
Top Coat

Finally, a top coat of High-Tensile Acrylic 211 was applied. This elastomeric product is designed to remain flexible even under conditions such as high foot traffic, extreme weather, and everyday wear-and-tear.

After receiving the Met-A-Gard+ system, the roof now has an attractive, watertight finish with at least 15 years of extended life. It is now protected from any further rust or corrosion thanks to the Red Oxide Rust Prime 912. American WeatherStar issued a 15-year material warranty on the Met-A-Gard+ system.
