METAL ROOF: THREE COURSE FABRIC REINFORCED

PENETRATION RESTORATION DETAIL

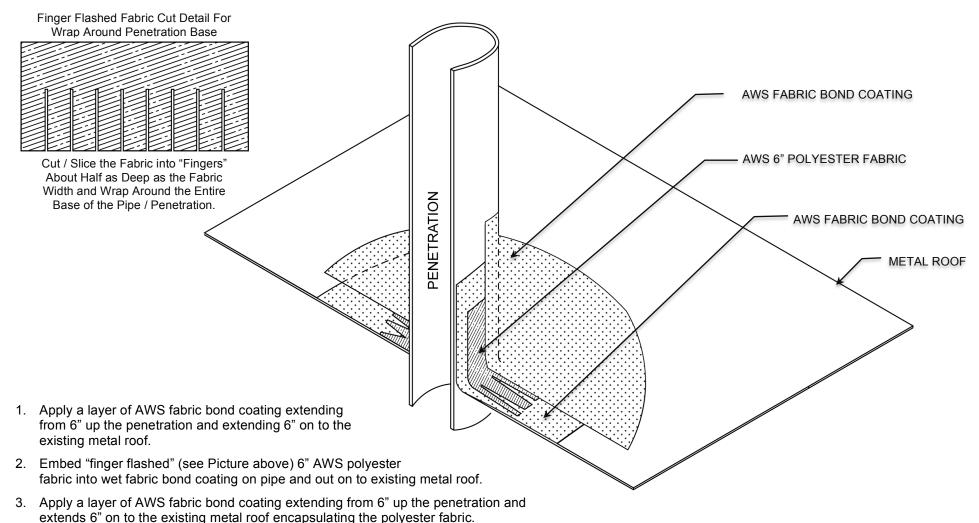
extends 6° on to the existing metal roof encapsulating the polyester fabric.

See specific application guideline for suitable AWS fabric bond coating.

FABRIC BOND COATING

POLYESTER FABRIC
